MUNICIPAL News

August 2011

WATER, WASTEWATER, TRANSPORTATION AND MUNICIPAL SPECIALISTS

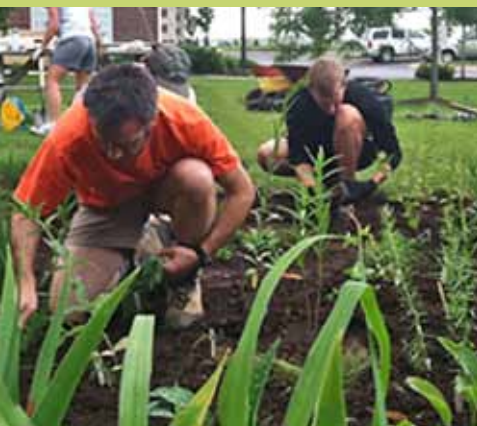
The Baxter & Woodman Sustainability Committee facilitated installation of rain gardens at two B&W office locations. After careful planning, site and plant selection, B&W staff rolled up their sleeves and dug in!

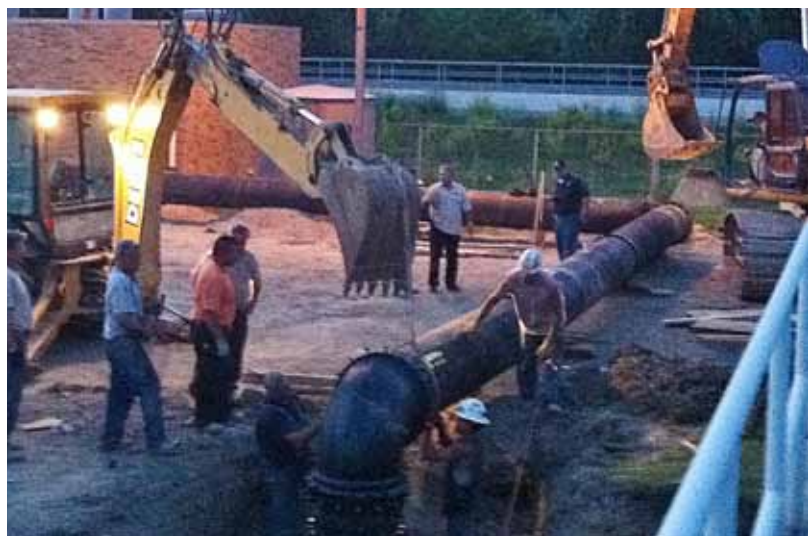
11:30 AM-9:00 PM Material arrives on site throughout the day. Approximately 60' of 24" pipe is run east into a 90° bend and another 60' of pipe is run south from there to a set of 90° bends. The connection to the existing pipe is made using the bottom 90° bend. Air compressors are connected to the tank air lines by way of the blow off lines to keep some air flowing throughout the repair process.

The City installs new ductile iron temporary piping to all of the tanks. None of the original ductile iron piping remains in use today.
